July 19, 2018 Table Rock Lake Near Branson, Missouri

Duck boat sinks in storm

Branson Duck Boat

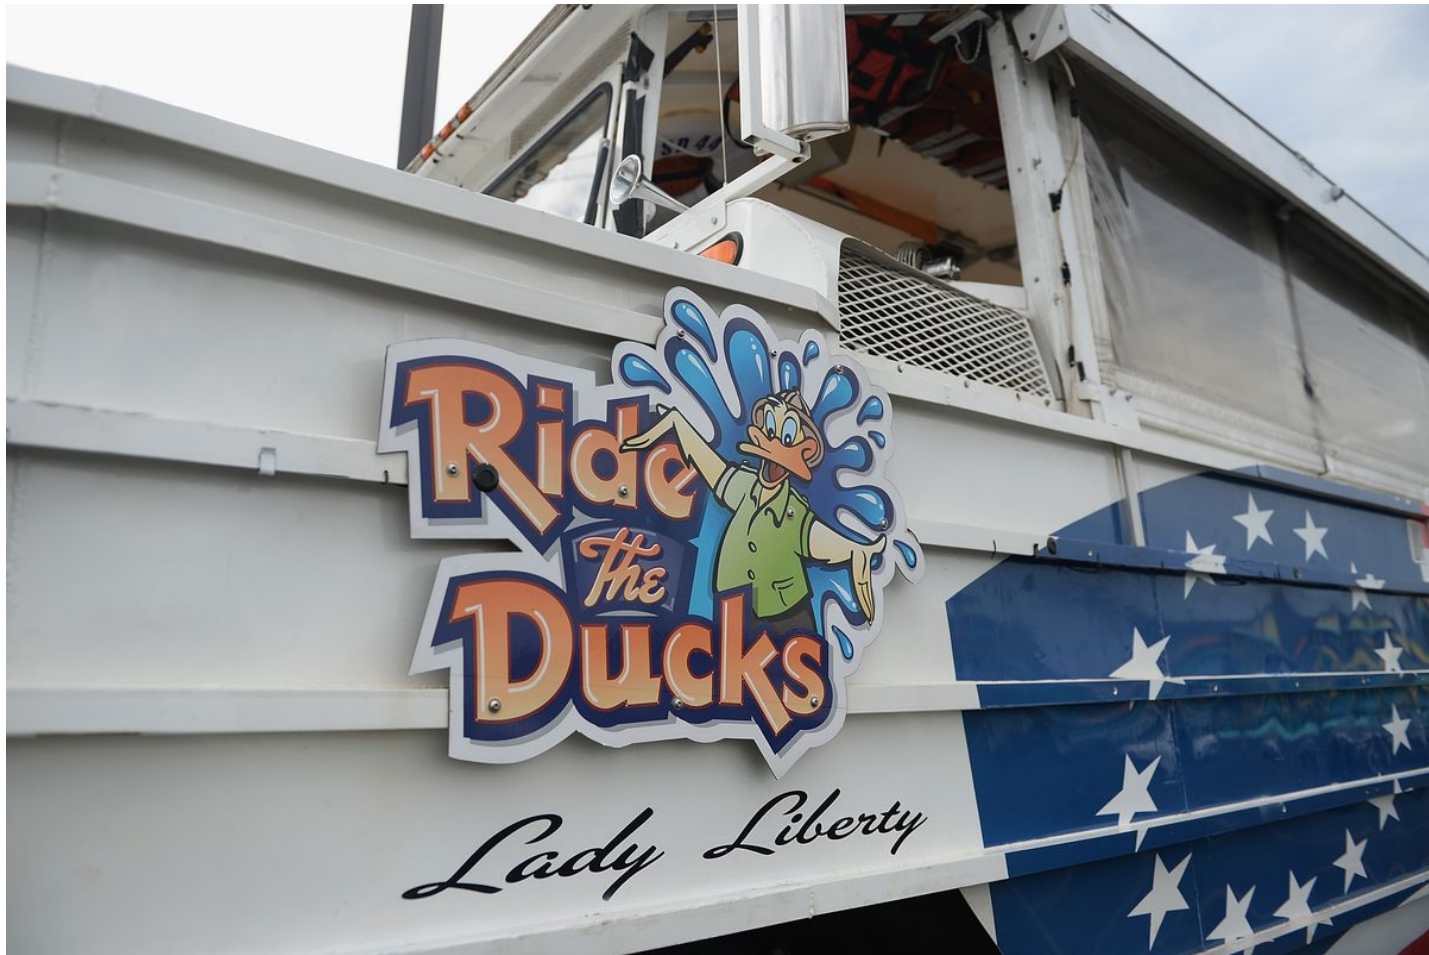
17 people perish

(including 9 members from one family and the driver)
